TOYOTA LANDCRUISER 200 SERIES LEFT SIDE

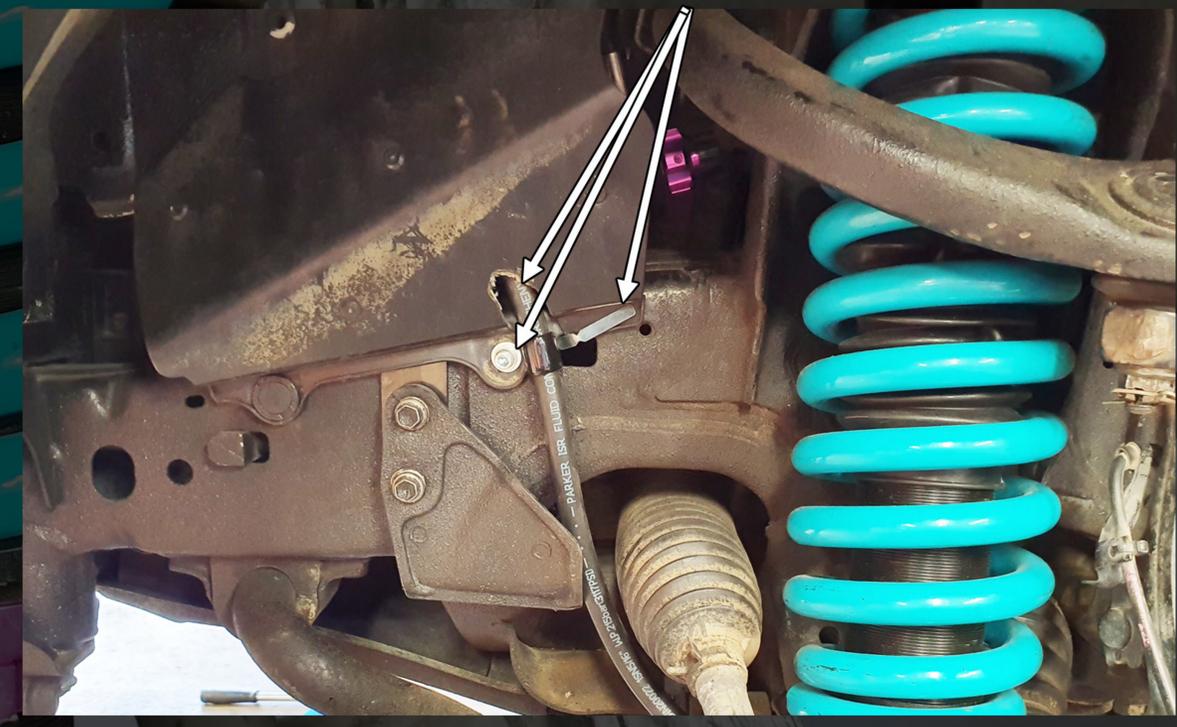
SOME DIESEL MODELS MAY REQUIRE CABLE INSIDE ENGINE BAY WRAPPED WITH PROTECTIVE SPIRAL WRAP IF TOUCHING SHOCK RESERVOIR

SHOWN WITH PLASTIC GUARD REMOVED FOR CLARITY.

RESERVOIR BOLTED TO RIGHT SIDE MOUNT WITH ADJUSTERS ABOUT 10MM FROM THE COIL TOWER AND THE HOSE LOOPED UP. HOSE FIXED WITH P-CLAMP TO EXISTING HOLE AND THROUGH PLASTIC COVER WITH BOLT AND HANDLE-NUT SUPPLIED

INSET: PLASTIC COVER RE-FITTED TO VEHICLE. IT WILL NEED A 15-20MM HOLE DRILLED APPROX. 40MM FROM THE BOTTOM OF THE GUARD AND THEN TRIMMED NEATLY FROM THE BOTTOM UP TO THE HOLE TO MAKE A SLOT TO CLEAR THE HOSE. IT IS THEN BOLTED TO THE P-CLAMP BOLT UNDER THE LARGER WASHER WITH THE TAIL OF THE HANDLE-NUT PUSHED AGAINST THE REAR OF THE GUARD TO HOLD IN PLACE.

HOSE RUNNING FORWARD ON THE INSIDE POSITIONED WITH ABOUT 5 - 10MM CLEARANCE TO STEERING RACK BOOT AT FULL DROOP AND STEERING AT FULL LOCK TO THE RIGHT.

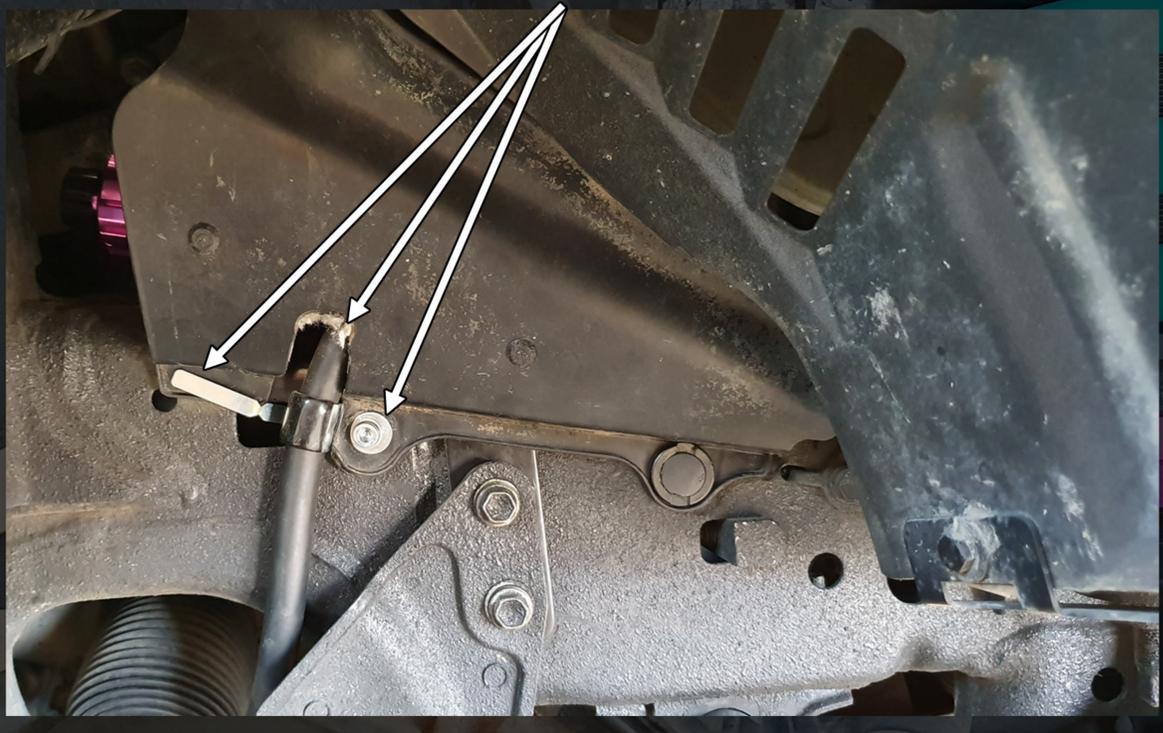
TOYOTA LANDCRUISER 200 SERIES RIGHT SIDE

SHOWN WITH PLASTIC GUARD REMOVED FOR CLARITY.

SOME DIESEL MODELS MAY REQUIRE HOSE INSIDE ENGINE BAY WRAPPED WITH PROTECTIVE SPIRAL WRAP IF TOUCHING SHOCK RESERVOIR

INSET: PLASTIC COVER RE-FITTED TO VEHICLE. IT WILL NEED A 15-20MM HOLE DRILLED APPROX. 40MM FROM THE BOTTOM OF THE GUARD AND THEN TRIMMED NEATLY FROM THE BOTTOM UP TO THE HOLE TO MAKE A SLOT TO CLEAR THE HOSE. IT IS THEN BOLTED TO THE P-CLAMP BOLT UNDER THE LARGER WASHER WITH THE TAIL OF THE HANDLE-NUT PUSHED AGAINST THE REAR OF THE GUARD TO HOLD IN PLACE.

RESERVOIR BOLTED TO RIGHT SIDE MOUNT WITH ADJUSTERS ABOUT 10MM FROM THE COIL TOWER AND THE HOSE LOOPED UP. HOSE FIXED WITH P-CLAMP TO EXISTING HOLE AND THROUGH PLASTIC COVER WITH BOLT AND HANDLE-NUT SUPPLIED

HOSE RUNNING FORWARD ON THE INSIDE POSITIONED WITH ABOUT 5 - 10MM CLEARANCE TO STEERING RACK BOOT AT FULL DROOP AND STEERING AT FULL LOCK TO THE RIGHT.
